CANTOR INSPECTIONS

Yale Ofer
2839 Ashby Ave
Berkeley, CA

Inspected by Matt Cantor
Member: American Society of Home Inspectors®

July 3, 2014

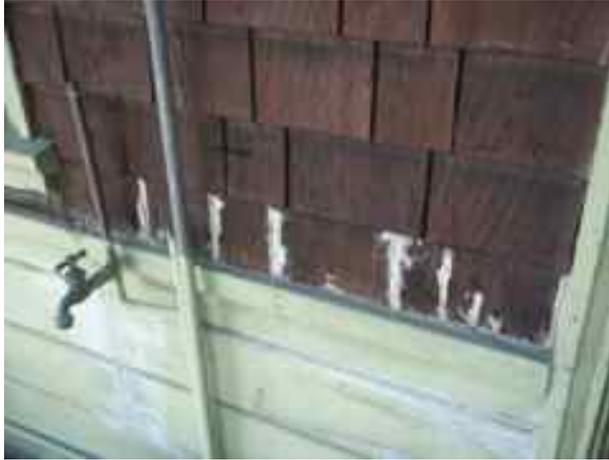
This building has horizontal wood siding that shows moderate to general wear and damage in several places. There is also wood shingle siding that is in moderately worn to poor condition and we recommend it be repaired and needed. Within the foreseeable future, it would be good to plan for the replacement of much of this shingle siding.

An example is shown below.

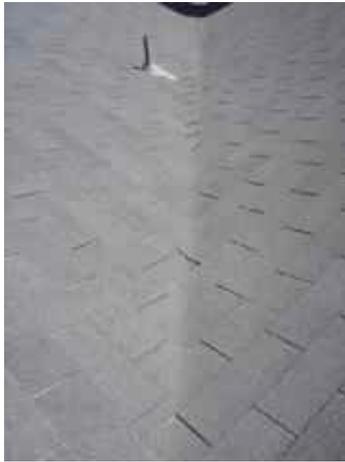
The house has a 3-tab, composition shingle roof, which we observed from its surface after climbing out of a skylight. This surface is approximately 20 years old, in generally worn condition. Given the age, the roof is in better than typical condition and may have 5 years or more left if properly maintained.

This roof is shown below.

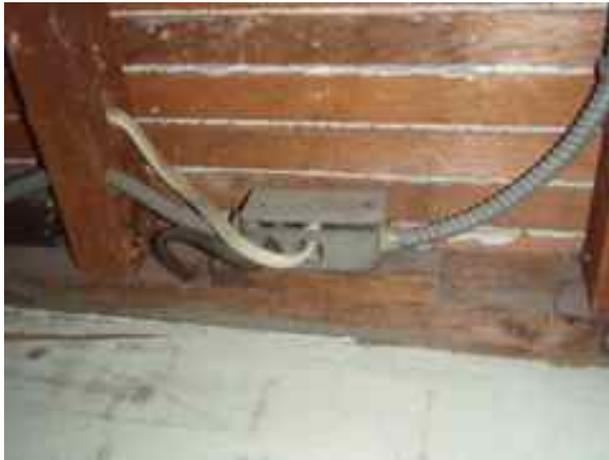
Wiring in the subfloor area is not properly supported. The general rule calls for staples or supports every four and one-half feet, and within 12-inches of each electrical box. We recommend the loose wiring be properly secured as needed. Wires are not properly installed at attic electrical box openings, as well as in other areas. This is shown below.

We recommend proper bushings and/or strain relief clamps be installed where wires enter box holes or openings.

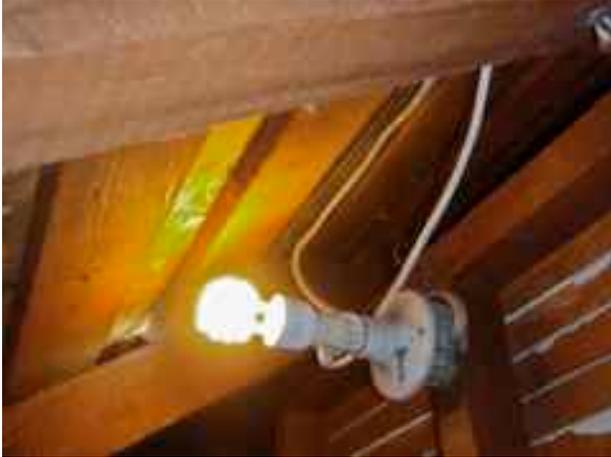
There are exposed bulb light fixtures in the attic near the roof, as well as in several closets. An example is shown below.

Incandescent light fixtures should be used in closets only when located over the door or on the ceiling and at least 12 inches from storage areas. Exposed bulbs and pendant lights should not be used. We recommend compact fluorescent lights (CFLs) be used in closets as they are cooler and require less clearance from storage areas.

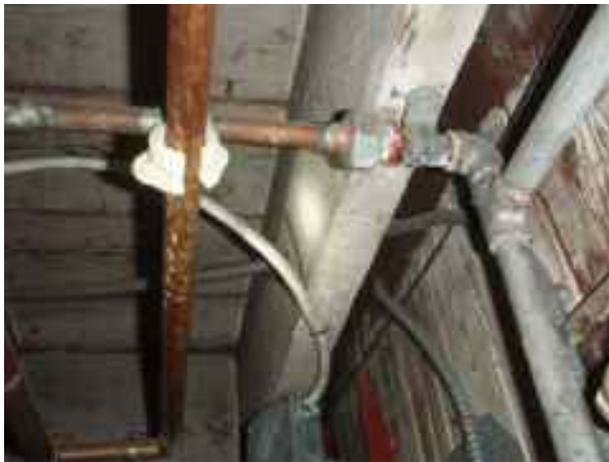
There is rust at several piping connections and on many fitting, especially near dielectric unions. An example is shown below. This is not unusual in galvanized piping. The rusty connections should be checked periodically for indications of leakage.

There is a significant drop in water flow when several valves are operated at the same time. We consider this system due for a major upgrade and we suggest that copper piping of ¾" at the main branches and ½" at dedicated branches be installed by a qualified plumber. Most of the angle stop valves are worn and may soon need replacement.

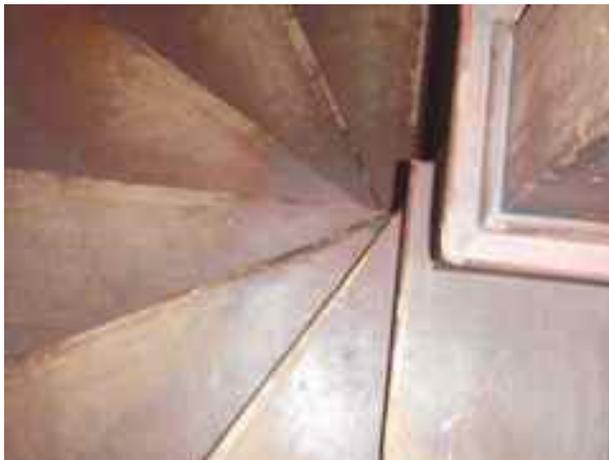
The stairs to the attic are winding and unsafe, shown below. We recommend caution be taken when traversing these stairs.

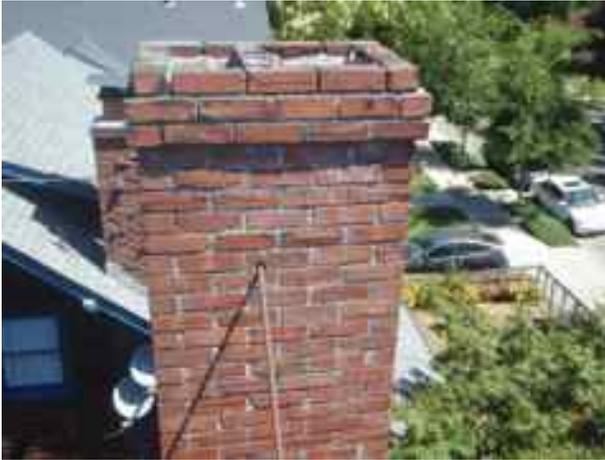
The chimney brick mortar shows softness and deterioration, this is shown below. The mortar between chimney bricks may become soft from age and moisture penetration. The standard repair method is to repoint the brickwork by scraping away old mortar and replacing it with new. Repointing is best performed by a qualified masonry contractor.
